HOME REPORT

TOP FLAT
70 WILLIAM STREET
TAYPORT
DD6 9HS

DM HALL
CHARTERED SURVEYORS

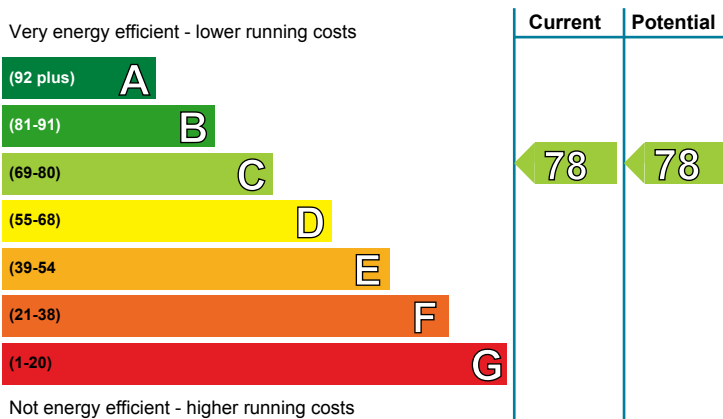
Energy Efficiency Rating

This graph shows the current efficiency of your home, taking into account both energy efficiency and fuel costs. The higher this rating, the lower your fuel bills are likely to be.

Your current rating is **band C (78)**. The average rating for EPCs in Scotland is **band D (61)**.

The potential rating shows the effect of undertaking all of the improvement measures listed within your recommendations report.

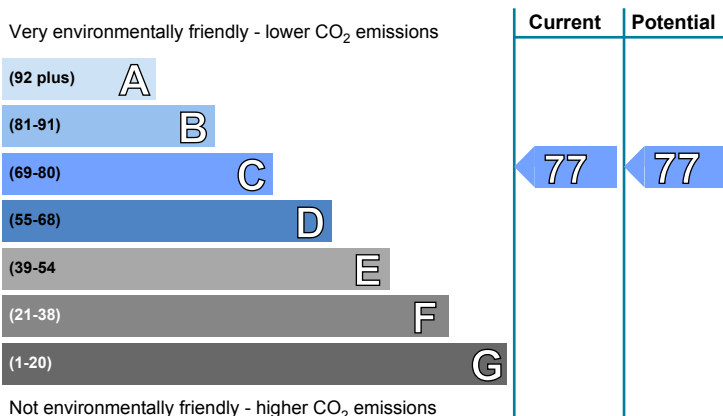
Environmental Impact (CO₂) Rating

This graph shows the effect of your home on the environment in terms of carbon dioxide (CO₂) emissions. The higher the rating, the less impact it has on the environment.

Your current rating is **band C (77)**. The average rating for EPCs in Scotland is **band D (59)**.

The potential rating shows the effect of undertaking all of the improvement measures listed within your recommendations report.
