# HOME REPORT

9 ROSEBANK MEWS  
DUNDEE  
DD3 6PS

# ENERGY PERFORMANCE CERTIFICATE

# Single Survey

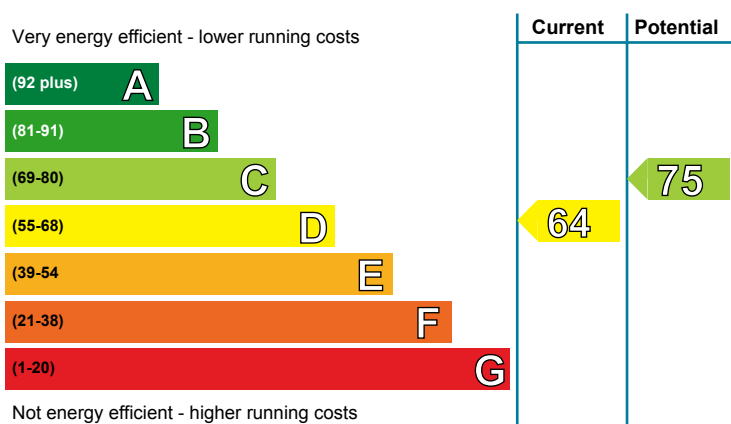
## Energy Efficiency Rating

This graph shows the current efficiency of your home, taking into account both energy efficiency and fuel costs. The higher this rating, the lower your fuel bills are likely to be.

Your current rating is **band D (64)**. The average rating for EPCs in Scotland is **band D (61)**.

The potential rating shows the effect of undertaking all of the improvement measures listed within your recommendations report.

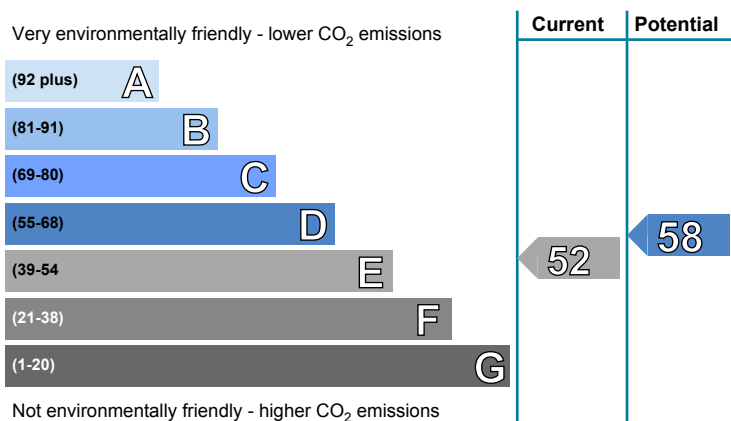
## Environmental Impact (CO<sub>2</sub>) Rating

This graph shows the effect of your home on the environment in terms of carbon dioxide (CO<sub>2</sub>) emissions. The higher the rating, the less impact it has on the environment.

Your current rating is **band E (52)**. The average rating for EPCs in Scotland is **band D (59)**.

The potential rating shows the effect of undertaking all of the improvement measures listed within your recommendations report.
