# HOME REPORT

72 WOODLANDS TERRACE  
DUNDEE  
DD4 9BA

# Energy Performance Certificate (EPC)

# Single Survey

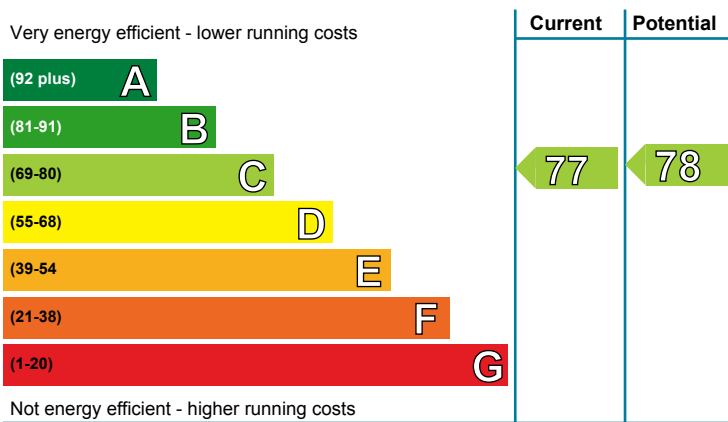
## Energy Efficiency Rating

This graph shows the current efficiency of your home, taking into account both energy efficiency and fuel costs. The higher this rating, the lower your fuel bills are likely to be.

Your current rating is **band C (77)**. The average rating for EPCs in Scotland is **band D (61)**.

The potential rating shows the effect of undertaking all of the improvement measures listed within your recommendations report.
