HOME REPORT

81 MACDONALD SMITH DRIVE CARNOUSTIE DD7 7TB

survey report on:

Property address	81 MACDONALD SMITH DRIVE CARNOUSTIE DD7 7TB
Customer	Mr S Wanless & Mrs C Wanless
Customer address	
Prepared by	DM Hall LLP
Date of inspection	12th April 2022

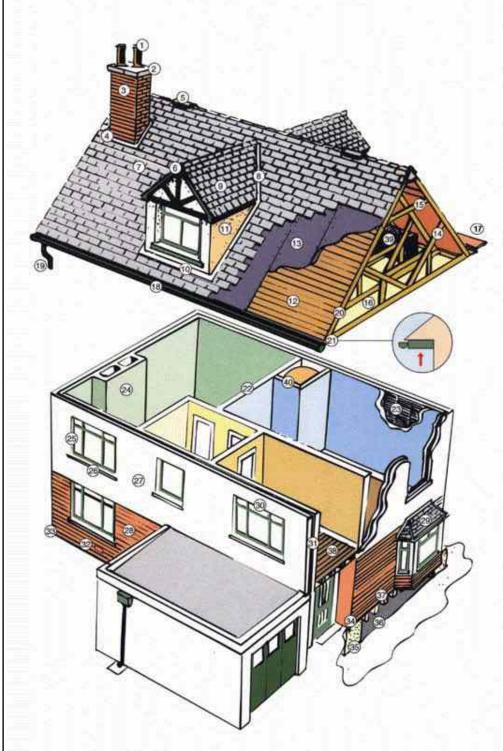
Sectional Diagram showing elements of a typical house

Reference may be made in this report to some or all of the above component parts of the property. This diagram may assist you in locating and understanding these items.

- 1) Chimney pots
- (2) Coping stone
- 3) Chimney head
- 4) Flashing
- (5) Ridge ventilation
- 6) Ridge board
- 7) Slates / tiles
- (8) Valley guttering
- 9) Dormer projection
- 10 Dormer flashing
- 11 Dormer cheeks
- 12) Sarking
- (13) Roof felt
- (14) Trusses
- 15) Collar
- (16) Insulation
- 7) Parapet gutter
- 18) Eaves guttering
- 19) Rainwater downpipe
- Verge boards /skews
- 21) Soffit boards
- 22) Partition wall
- 23) Lath / plaster
- 24) Chimney breast
- 25) Window pointing
- 26) Window sills
- (27) Rendering
- (28) Brickwork / pointing
- (29) Bay window projection
- (30) Lintels
- (31) Cavity walls / wall ties
- 32) Subfloor ventilator
- 33) Damp proof course
- 34) Base course
- 35) Foundations
- 36) Solum
- 37) Floor joists
- 38) Floorboards
- 9) Water tank
- 10) Hot water tank
