# HOME REPORT

**BANKGATE COTTAGE  
2 BALMUIR  
DUNDEE  
DD3 0PA**

# Energy Performance Certificate (EPC)

2 Bankgate Cottages, Strathmartine, Dundee, DD3 0PA

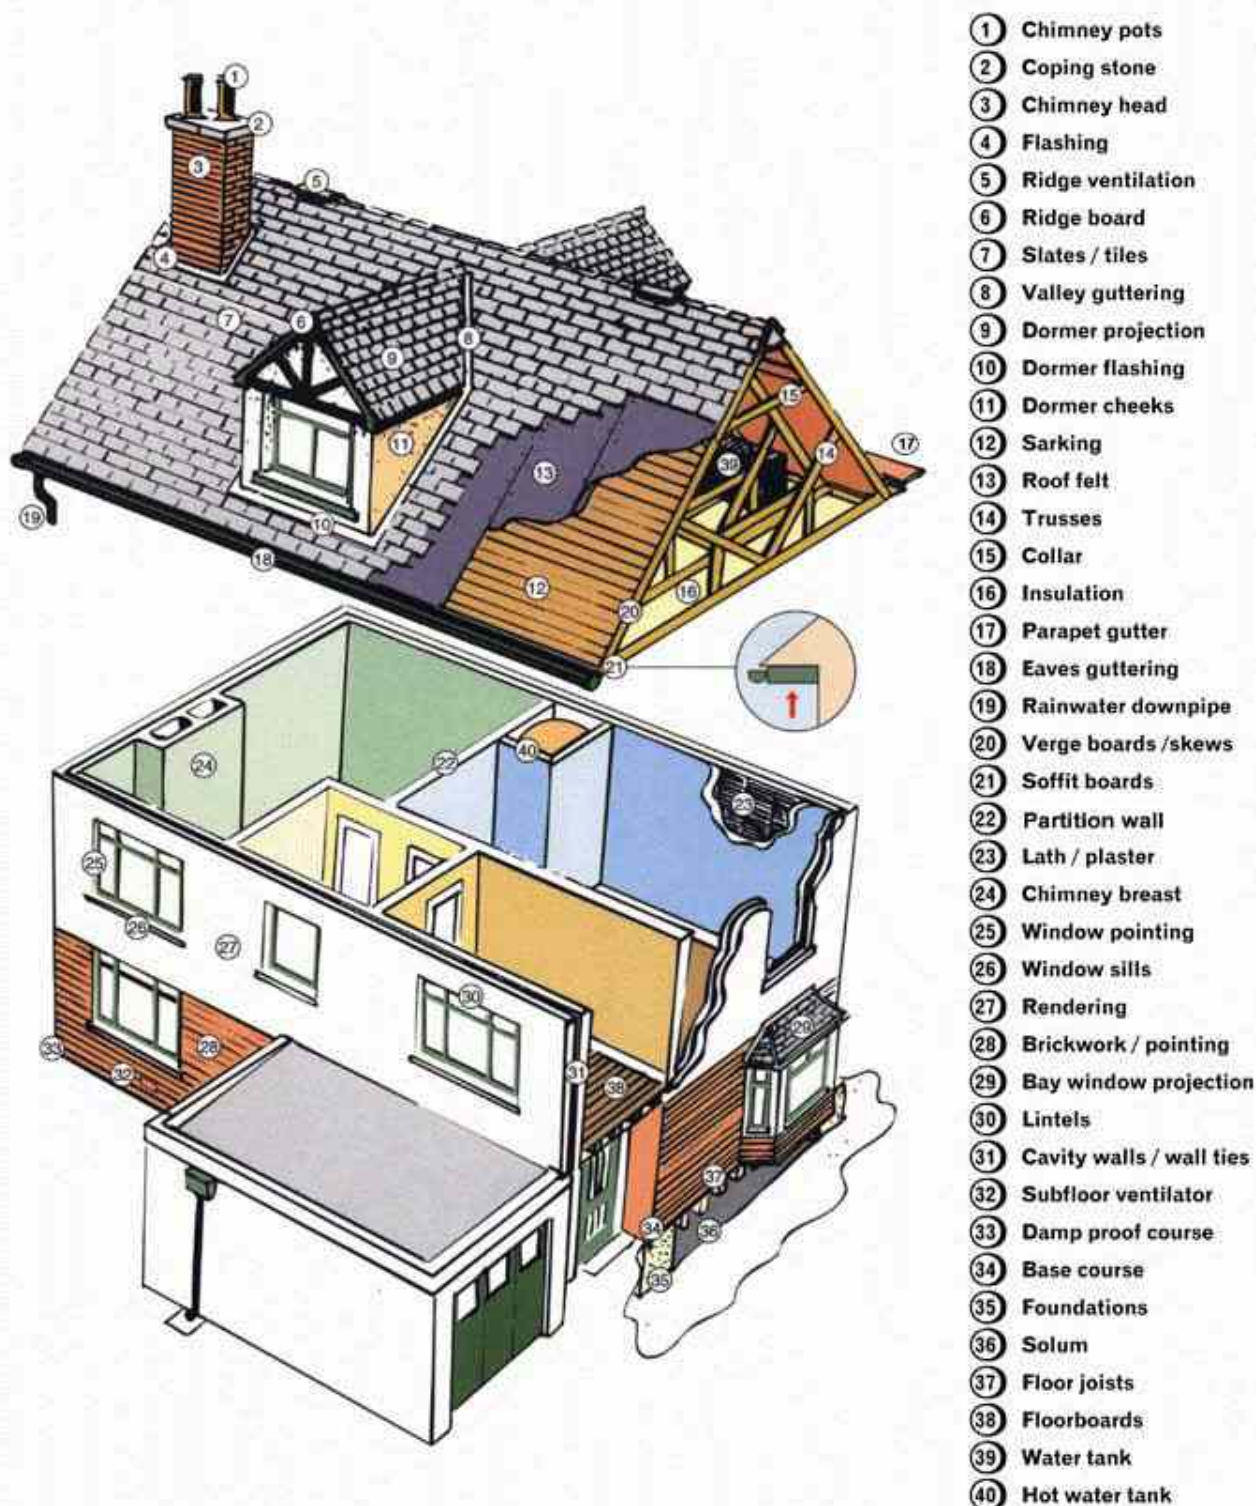
## Sectional Diagram showing elements of a typical house

Reference may be made in this report to some or all of the above component parts of the property. This diagram may assist you in locating and understanding these items.
