# HOME REPORT

57 TULLIDEPH ROAD  
DUNDEE  
DD2 2JE

# Single Survey

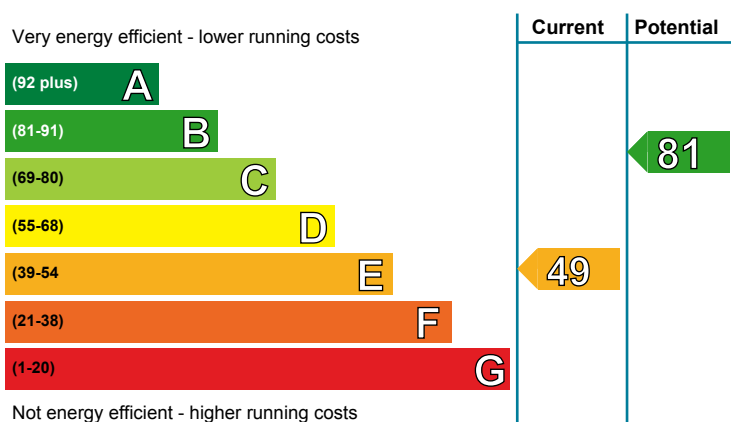
## Energy Efficiency Rating

This graph shows the current efficiency of your home, taking into account both energy efficiency and fuel costs. The higher this rating, the lower your fuel bills are likely to be.

Your current rating is **band E (49)**. The average rating for EPCs in Scotland is **band D (61)**.

The potential rating shows the effect of undertaking all of the improvement measures listed within your recommendations report.

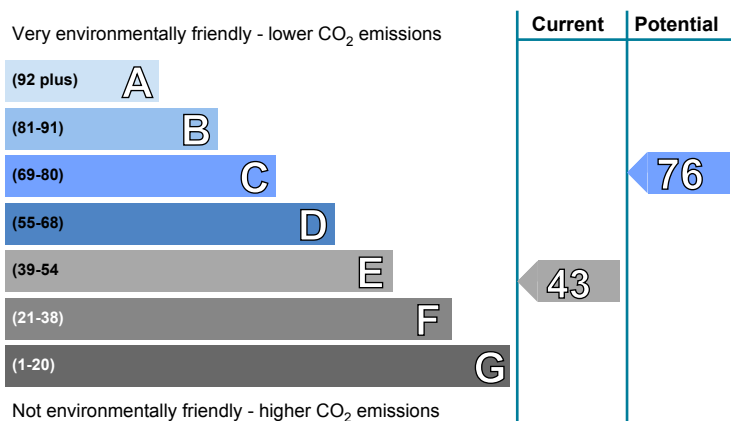
## Environmental Impact (CO<sub>2</sub>) Rating

This graph shows the effect of your home on the environment in terms of carbon dioxide (CO<sub>2</sub>) emissions. The higher the rating, the less impact it has on the environment.

Your current rating is **band E (43)**. The average rating for EPCs in Scotland is **band D (59)**.

The potential rating shows the effect of undertaking all of the improvement measures listed within your recommendations report.
