HOME REPORT

67 ULLAPOOL CRESCENT
DUNDEE
DD2 4TT

Energy Performance Certificate (EPC)

Single Survey

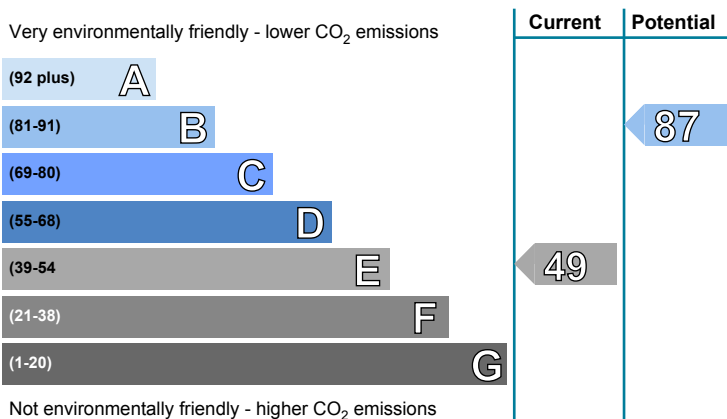
Environmental Impact (CO₂) Rating

This graph shows the effect of your home on the environment in terms of carbon dioxide (CO₂) emissions. The higher the rating, the less impact it has on the environment.

Your current rating is **band E (49)**. The average rating for EPCs in Scotland is **band D (59)**.

The potential rating shows the effect of undertaking all of the improvement measures listed within your recommendations report.
