# HOME REPORT

23B LONG LANE  
BROUGHTY FERRY  
DUNDEE  
DD5 1ER

# Energy Performance Certificate (EPC)

23B LONG LANE, BROUGHTY FERRY, DUNDEE, DD5 1ER

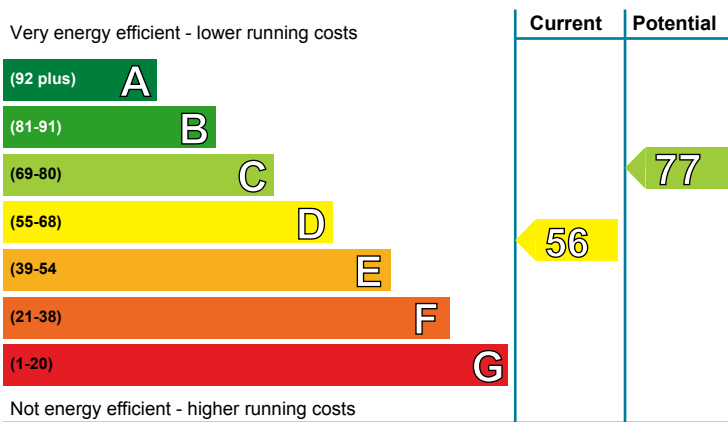
## Energy Efficiency Rating

This graph shows the current efficiency of your home, taking into account both energy efficiency and fuel costs. The higher this rating, the lower your fuel bills are likely to be.

Your current rating is **band D (56)**. The average rating for EPCs in Scotland is **band D (61)**.

The potential rating shows the effect of undertaking all of the improvement measures listed within your recommendations report.

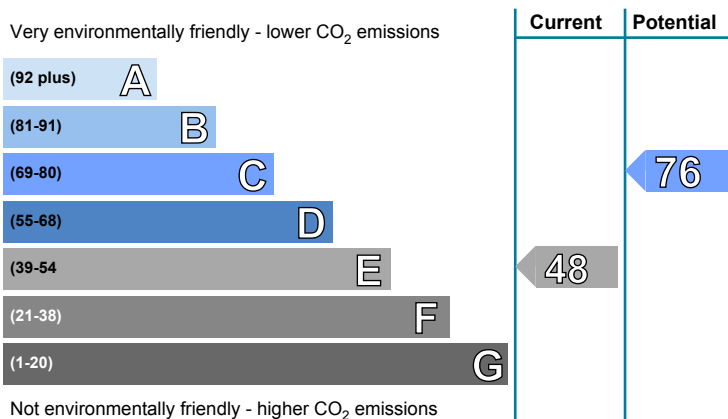
## Environmental Impact (CO<sub>2</sub>) Rating

This graph shows the effect of your home on the environment in terms of carbon dioxide (CO<sub>2</sub>) emissions. The higher the rating, the less impact it has on the environment.

Your current rating is **band E (48)**. The average rating for EPCs in Scotland is **band D (59)**.

The potential rating shows the effect of undertaking all of the improvement measures listed within your recommendations report.
