# HOME REPORT

18 BALGARTHNO PLACE  
DUNDEE  
DD2 4QG

# ENERGY PERFORMANCE CERTIFICATE

# SINGLE SURVEY

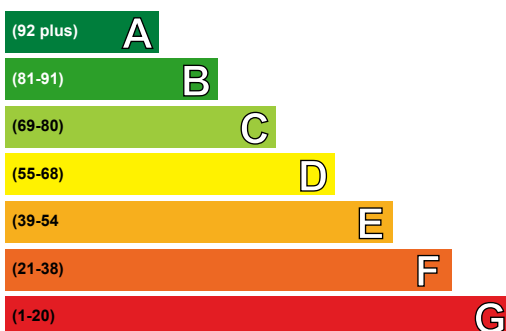
## Energy Efficiency Rating

This graph shows the current efficiency of your home, taking into account both energy efficiency and fuel costs. The higher this rating, the lower your fuel bills are likely to be.

Your current rating is **band D (66)**. The average rating for EPCs in Scotland is **band D (61)**.

The potential rating shows the effect of undertaking all of the improvement measures listed within your recommendations report.
