# **HOME REPORT**

**41 IVY ROAD FORFAR DD8 3EF**

# SINGLE SURVEY

Property address	41 IVY ROAD FORFAR ANGUS DD8 3EF
Customer	LEANNE LIVIE
Customer address	
Prepared by	DM Hall LLP
Date of inspection	29th July 2022

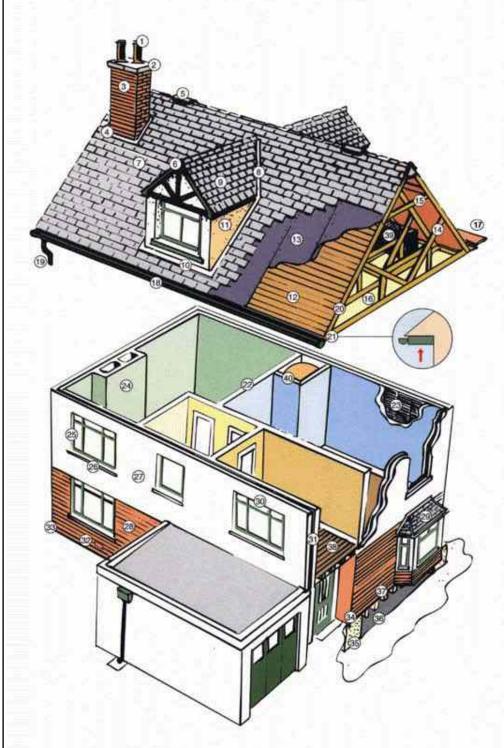
### Sectional Diagram showing elements of a typical house

Reference may be made in this report to some or all of the above component parts of the property. This diagram may assist you in locating and understanding these items.

- 1) Chimney pots
- 2 Coping stone
- 3) Chimney head
- 4) Flashing
- 5 Ridge ventilation
- 6) Ridge board
- 7) Slates / tiles
- 8 Valley guttering
- 9) Dormer projection
- 10 Dormer flashing
- 11) Dormer cheeks
- (12) Sarking
- 13) Roof felt
- (14) Trusses
- 15) Collar
- (16) Insulation
- 7) Parapet gutter
- 18) Eaves guttering
- (19) Rainwater downpipe
- O Verge boards /skews
- 21) Soffit boards
- 22) Partition wall
- 23) Lath / plaster
- 24) Chimney breast
- 25) Window pointing
- 26) Window sills
- (27) Rendering
- (28) Brickwork / pointing
- 29 Bay window projection
- (30) Lintels
- (31) Cavity walls / wall ties
- 32) Subfloor ventilator
- 33) Damp proof course
- 34) Base course
- 35) Foundations
- 36) Solum
- 37) Floor joists
- 38) Floorboards
- 9) Water tank
- 40) Hot water tank
