HOME REPORT

FLAT 2/1
18 CASTLE STREET
FORFAR
DD8 3AD

Energy Performance Certificate (EPC)

FLAT 2/1 , 18 CASTLE STREET, FORFAR, DD8 3AD

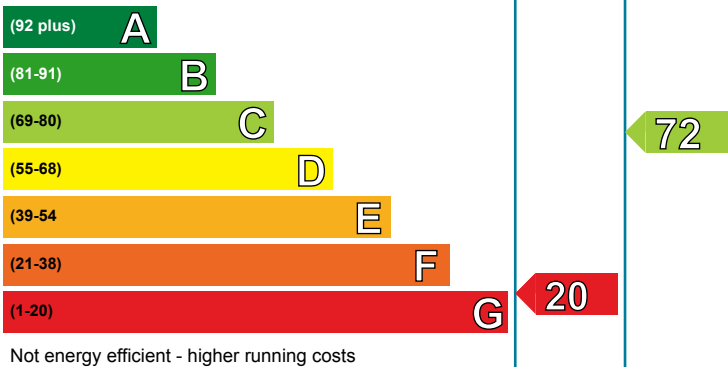
Energy Efficiency Rating

This graph shows the current efficiency of your home, taking into account both energy efficiency and fuel costs. The higher this rating, the lower your fuel bills are likely to be.

Your current rating is **band G (20)**. The average rating for EPCs in Scotland is **band D (61)**.

The potential rating shows the effect of undertaking all of the improvement measures listed within your recommendations report.

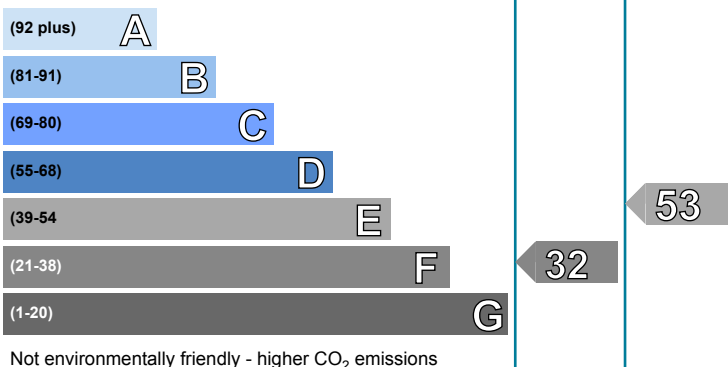
Environmental Impact (CO₂) Rating

This graph shows the effect of your home on the environment in terms of carbon dioxide (CO₂) emissions. The higher the rating, the less impact it has on the environment.

Your current rating is **band F (32)**. The average rating for EPCs in Scotland is **band D (59)**.

The potential rating shows the effect of undertaking all of the improvement measures listed within your recommendations report.
