HOME REPORT

3 WYLLIE STREET
FORFAR
DD8 3DN

Energy Performance Certificate (EPC)

3 WYLLIE STREET, FORFAR, DD8 3DN

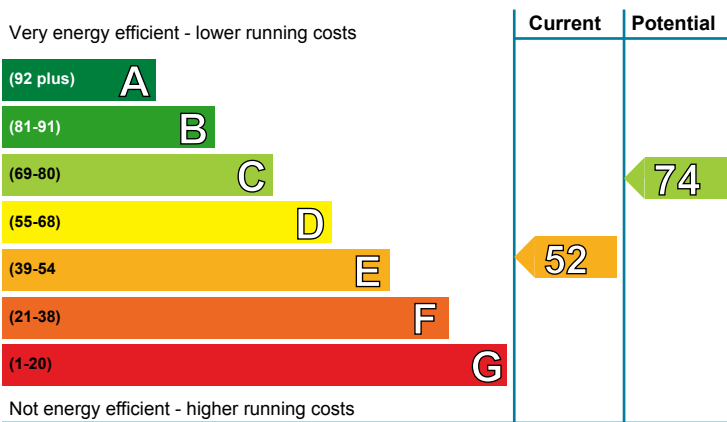
Energy Efficiency Rating

This graph shows the current efficiency of your home, taking into account both energy efficiency and fuel costs. The higher this rating, the lower your fuel bills are likely to be.

Your current rating is **band E (52)**. The average rating for EPCs in Scotland is **band D (61)**.

The potential rating shows the effect of undertaking all of the improvement measures listed within your recommendations report.
