# HOME REPORT

37 ELM ROAD  
KIRRIEMUIR  
DD8 4DG

# Energy Performance Certificate (EPC)

37 ELM ROAD, KIRRIEMUIR, DD8 4DG

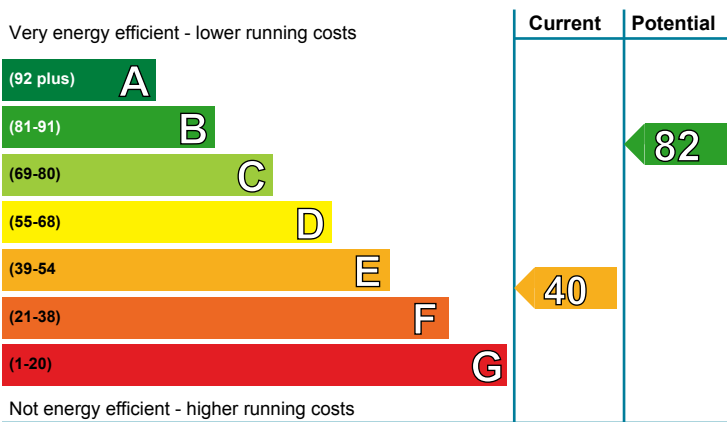
## Energy Efficiency Rating

This graph shows the current efficiency of your home, taking into account both energy efficiency and fuel costs. The higher this rating, the lower your fuel bills are likely to be.

Your current rating is **band E (40)**. The average rating for EPCs in Scotland is **band D (61)**.

The potential rating shows the effect of undertaking all of the improvement measures listed within your recommendations report.

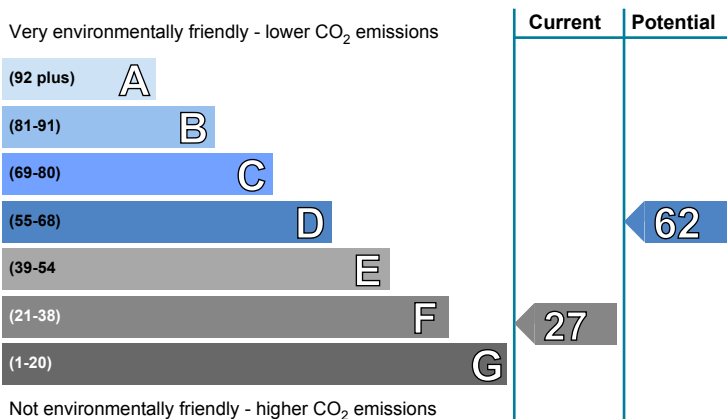
## Environmental Impact (CO<sub>2</sub>) Rating

This graph shows the effect of your home on the environment in terms of carbon dioxide (CO<sub>2</sub>) emissions. The higher the rating, the less impact it has on the environment.

Your current rating is **band F (27)**. The average rating for EPCs in Scotland is **band D (59)**.

The potential rating shows the effect of undertaking all of the improvement measures listed within your recommendations report.
