HOME REPORT

66A CASTLE STREET
BROUGHTY FERRY
DUNDEE
DD5 2EJ

Energy Performance Certificate (EPC)

66A CASTLE STREET, BROUGHTY FERRY, DUNDEE, DD5 2EJ

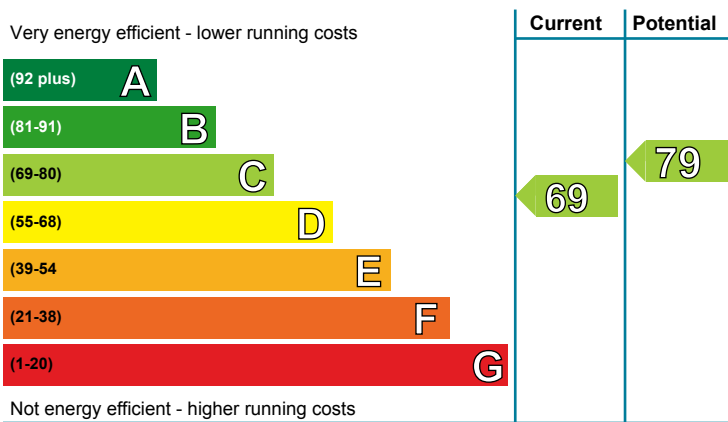
Energy Efficiency Rating

This graph shows the current efficiency of your home, taking into account both energy efficiency and fuel costs. The higher this rating, the lower your fuel bills are likely to be.

Your current rating is **band C (69)**. The average rating for EPCs in Scotland is **band D (61)**.

The potential rating shows the effect of undertaking all of the improvement measures listed within your recommendations report.

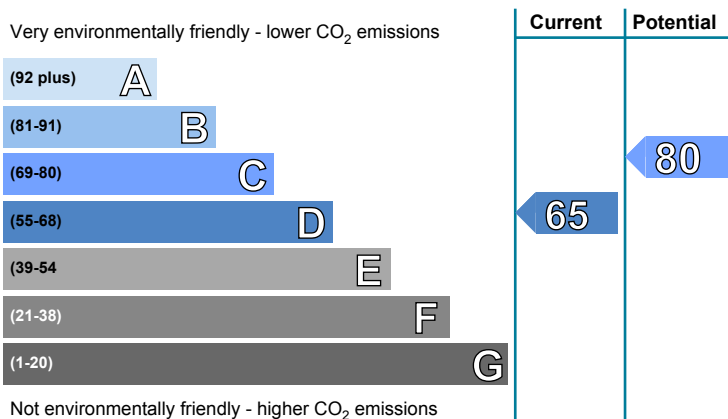
Environmental Impact (CO₂) Rating

This graph shows the effect of your home on the environment in terms of carbon dioxide (CO₂) emissions. The higher the rating, the less impact it has on the environment.

Your current rating is **band D (65)**. The average rating for EPCs in Scotland is **band D (59)**.

The potential rating shows the effect of undertaking all of the improvement measures listed within your recommendations report.

The average Scottish household produces about 6 tonnes of carbon dioxide every year. Based on this assessment, heating and lighting this home currently produces approximately 3.5 tonnes of carbon dioxide every year. Adopting recommendations in this report can reduce emissions and protect the environment. If you were to install all of these recommendations this could reduce emissions by 1.5 tonnes per year. You could reduce emissions even more by switching to renewable energy sources.
