HOME REPORT

15 OSBORNE PLACE
DUNDEE
DD2 1BE

Energy Performance Certificate (EPC)

15 OSBORNE PLACE, DUNDEE, DD2 1BE

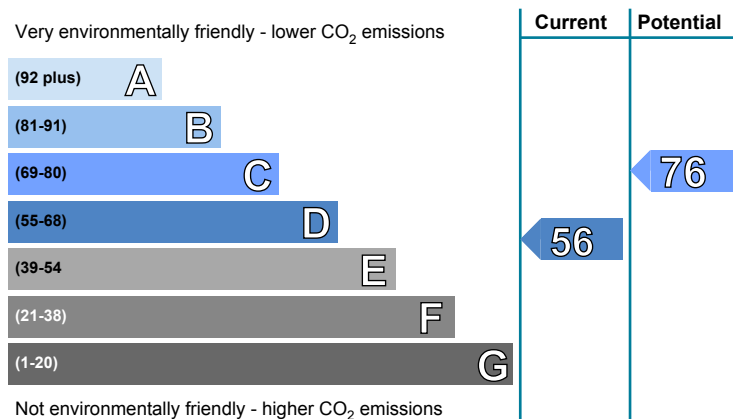
Environmental Impact (CO₂) Rating

This graph shows the effect of your home on the environment in terms of carbon dioxide (CO₂) emissions. The higher the rating, the less impact it has on the environment.

Your current rating is **band D (56)**. The average rating for EPCs in Scotland is **band D (59)**.

The potential rating shows the effect of undertaking all of the improvement measures listed within your recommendations report.
