# HOME REPORT

54 DUNDEE ROAD  
BROUGHTY FERRY  
DUNDEE  
DD5 1HY

# Energy Performance Certificate (EPC)

# Single Survey

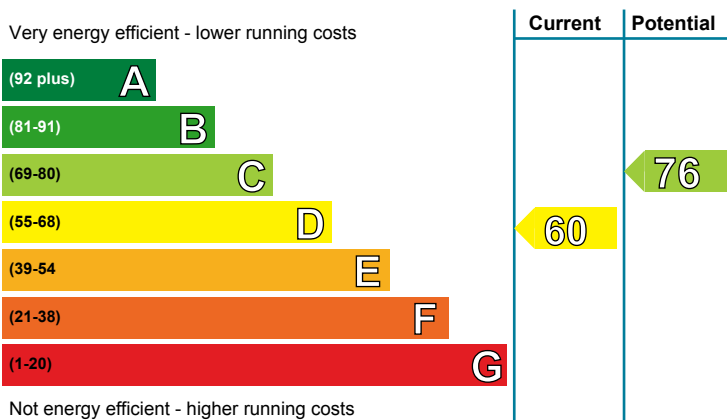
## Energy Efficiency Rating

This graph shows the current efficiency of your home, taking into account both energy efficiency and fuel costs. The higher this rating, the lower your fuel bills are likely to be.

Your current rating is **band D (60)**. The average rating for EPCs in Scotland is **band D (61)**.

The potential rating shows the effect of undertaking all of the improvement measures listed within your recommendations report.

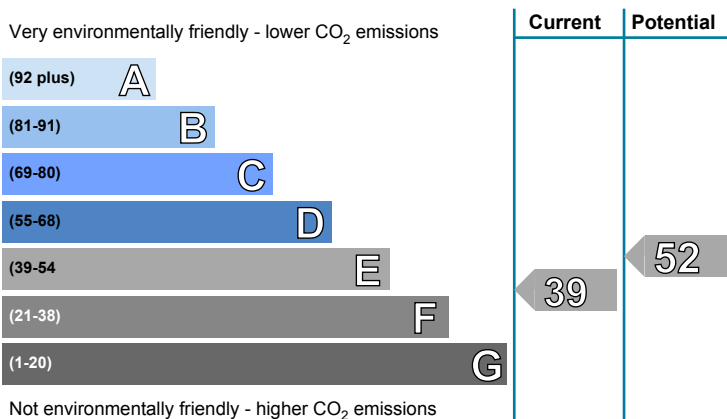
## Environmental Impact (CO<sub>2</sub>) Rating

This graph shows the effect of your home on the environment in terms of carbon dioxide (CO<sub>2</sub>) emissions. The higher the rating, the less impact it has on the environment.

Your current rating is **band E (39)**. The average rating for EPCs in Scotland is **band D (59)**.

The potential rating shows the effect of undertaking all of the improvement measures listed within your recommendations report.
